Goliath Gantry Cranes

Their Steel Structure – A Neglected Element

Experiences in Surveillance and Reconditioning of the Last Two Decades

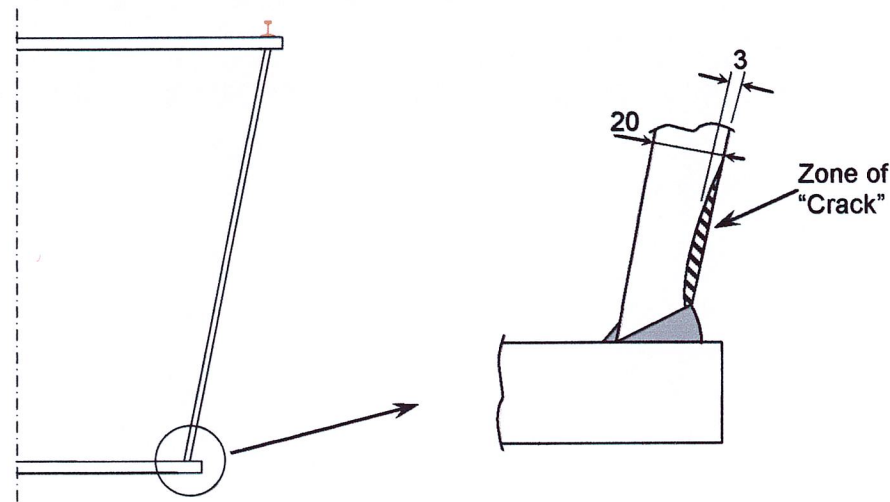
Figure 1: Material defects – Case 1.

This case refers to a defect discovered in the lower part of web of the main beam of a large gantry crane, near the joint with the bottom flange (see Figure 1). It existed at mid-span, extending for a length of approx. 600 mm and a height of 50 mm above the bottom flange. It was discovered by the Alternating Current Field Measurement (ACFM) method. First it had appearance of a crack, but after careful examination and grinding it was established that it was a “lap” in the plate, present since the origin that after the years became loose. Careful grinding of the area was carried out until the defect was eliminated. No re-welding was envisaged due to tensile stress permanently present in this area from the main beam own weight, reaching approximately 100 MPa.

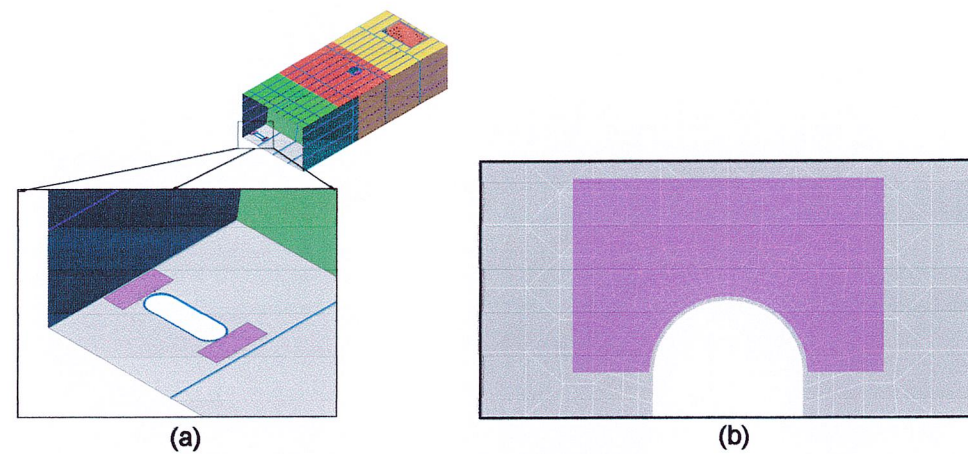
Figure 2: Design errors – Case 1.

The design problem in this case was a cable hole in the bottom flange of a cross beam of the crane, being oriented with its largest dimension perpendicular to the direction of principal tensile stresses developed in the plate (see Figure 2a, where half of the cross beam is shown for better illustration). This configuration resulted in a large stress concentration at the edges of the hole, which in time could have jeopardized structural integrity of the cross beam. The area was reinforced by putting friction-bolted doubler plates near the edges of

the cable hole. Various shapes were investigated by using finite elements, with the one shown in Figure 2b found to be the optimum one.

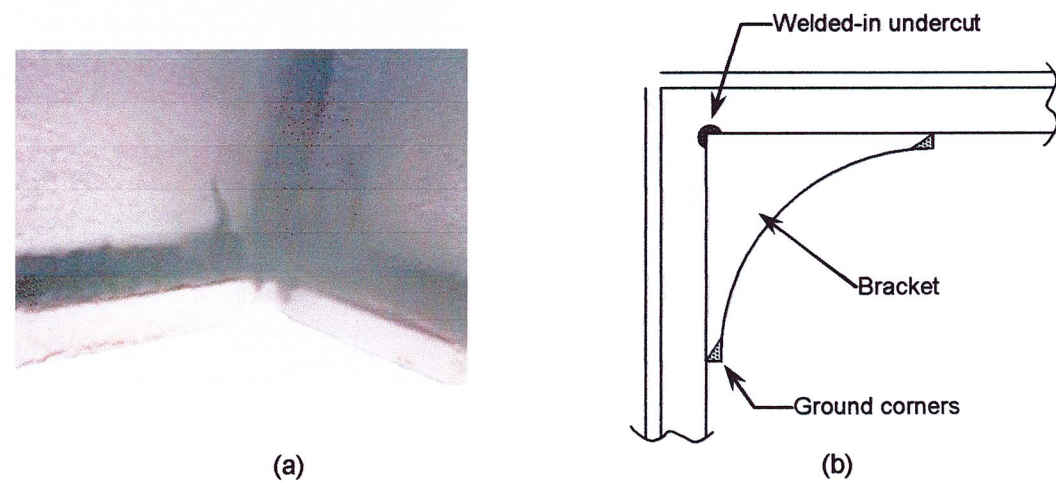
Figure 3: Design errors – Case 2.

The problem was the existence of an undercut in a junction of bottom flanges of two beams of a trolley (Figure 3a), both these flanges being loaded in tension. Repair works included filling of the undercut with weld and welding of an additional curved bracket, as shown in Figure 3b). The initial right-angle corners of the bracket were, after welding of bracket to the beams, ground smooth for optimum geometry.

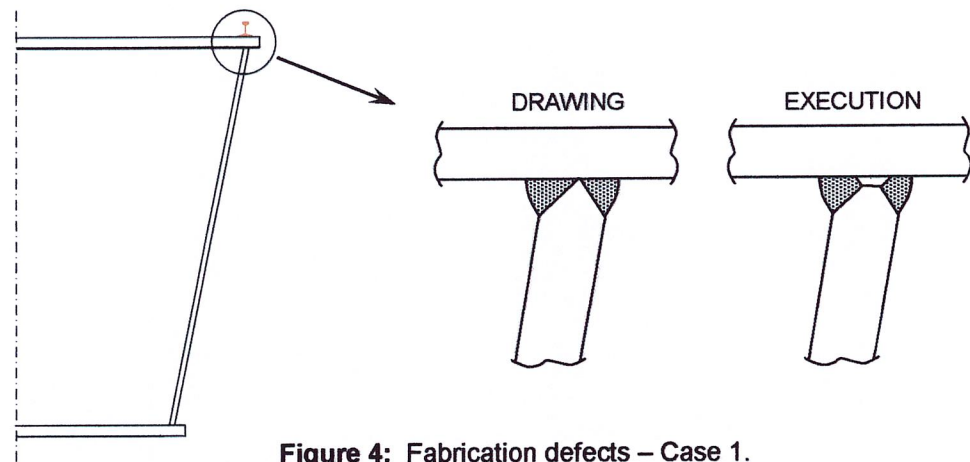
Figure 4: Fabrication defects – Case 1.

In this case, the problem concerned improper execution of throat weld between the top flange and the web of main beam of the crane, just below the trolley rail (Figure 4). Insufficient penetration of this welding resulted in development of a longitudinal crack in the weld extending for about 200 mm, discovered by the ACFM method. The crack was repaired

by careful removal and rewelding limited to the area where the crack was found. Although the problematic throat weld was extending along the whole length of the section involved (16 m), for practical reasons it was not possible to repair the whole weld. The yard was informed to pay specific attention to this area during future surveys.

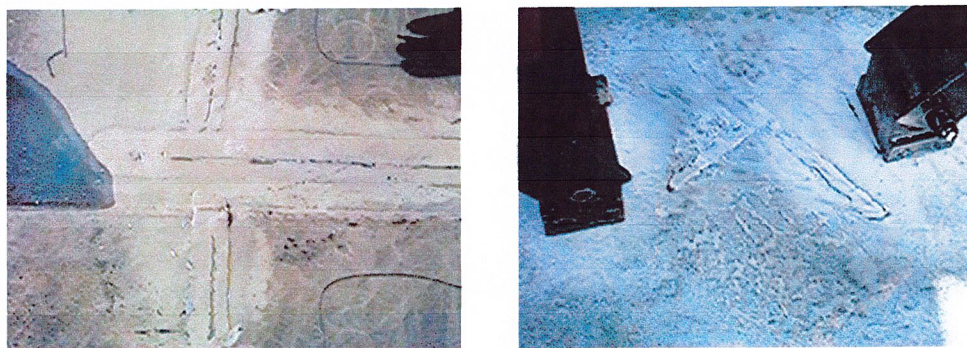
Figure 5: Fabrication defects – Case 2, two different examples.

In many cases, remnants of gussets and brackets used for fabrication and/or erection purposes were found like those shown in Figure 5 below. These remnants were traces of weld metal due to improper removal of these structural appendices leading to cracks in some cases. The cracks were discovered by grinding out these remnants and investigating the area with NDT techniques. Repair was limited to grinding out the cracks, since they were not deep.

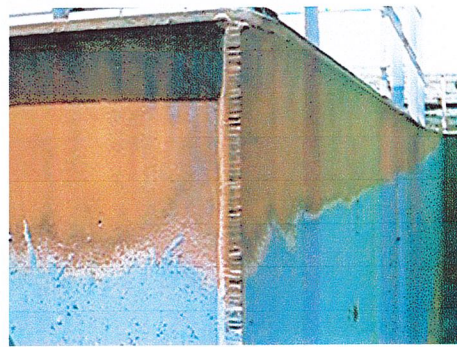
Figure 6: Fabrication defects – Case 3.

A common fabrication defect is poor quality of edge cutting of various free edge plates, like the one shown in Figure 6 of the cross beam web plating. These saw-tooth shaped edges are a perfect example of potential crack initiation points, when they are parallel to

main tensile stresses of the structure. The problem was resolved by grinding the edges smooth and checking with magnetic particles to verify that no micro-cracks remained behind.

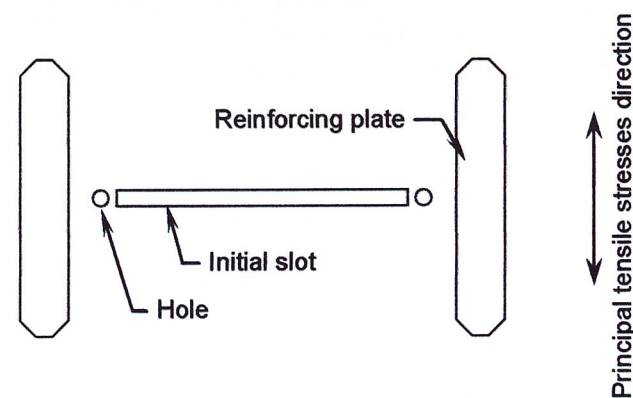
Figure 7: Erection defects – Case 1.

This case is about a situation on the main beam of a Goliath crane equipped with a bracket. In the area of maximum tensile stress of the beam top flange, lifting plates for erection purposes were introduced passing through the tension flange in a direction perpendicular to the principal stress (Figure 7). After erection these plates were cut off flush with the top surface of the flange. The erector, being aware of having done something incorrect, drilled a hole on each side of the slotted plate, introducing a bolt in each, spot-welded to the flange. In addition, a reinforcing plate was designed and welded to the flange on each side of the detail (Figure 7). The result was creation of cracks in the bolt holes, with much worse potential damage to be expected from such arrangement. Repair included removal of existing reinforcing plates and designing and installing friction-grip bolted doubler plates on both sides of the flange, around the critical area.

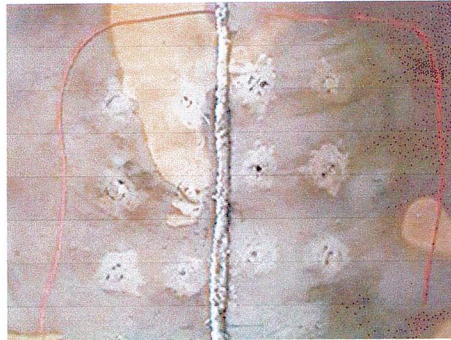
Figure 8: Erection defects – Case 2.

This example concerns bolt holes drilled initially to accommodate bolting of connection plates in order to join by welding sections of the crane beam. After assembly, these holes

were normally filled in by welding. In several cases, this welding was done improperly resulting in formation of defects like those shown in Figure 8, leading to severe stress concentrations. These defects were visually discovered after removal of paint. Initial attempt to re-weld the holes with preheat led to formation of cracks. This fact indicated that the parent material was very brittle, indicating execution of the initial fill-in welds at a low temperature and without preheat. Final solution was to re-drill the holes, preheat and re-weld.

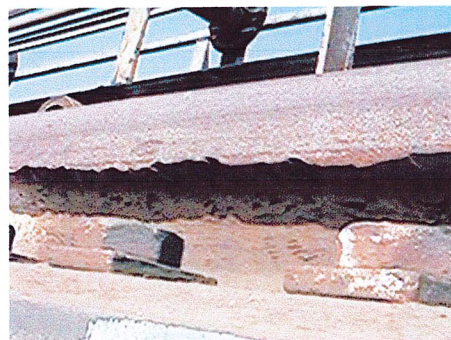
Figure 9: Erection defects – Case 3.

This case refers to the damage done to the service crane rails in order to fit the power tool socket on the bolt head to torque up the bolts. The bottom of the rail head was oxy-cut to make more space for the socket, as can be seen in Figure 9. No corrective measures were taken in this case, as the damage was characterized as irreparable. It has to be noted that these rails, friction-grip bolted to the main beam (hence part of the cross-section) are located in a zone of maximum tensile stress of the top flange, due to bracket action mentioned in paragraph 4.7.

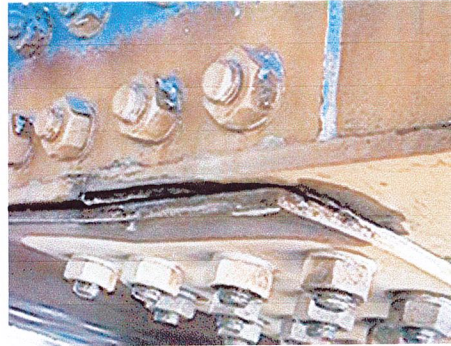
Figure 10: Corrosion – Case 1.

As shown in Figure 10, extensive corrosion was discovered at a friction-grip bolted joint of the main beam, due to insufficient attention paid to the water tightness of this joint. Corrective measures consisted of removal of rust as much as possible and sealing the joint.

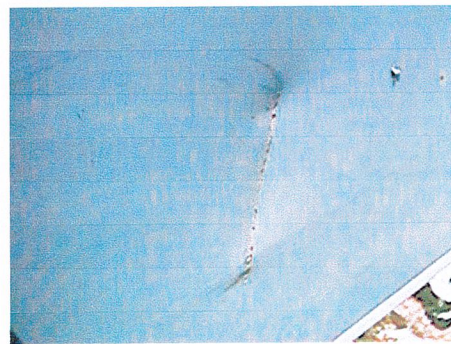
Figure 11: Operational damage – Case 1.

This example involves damage to one of the main beam webs near the counterweight area, due to collision with another crane (Figure 11). Compressive strength of the web plating has been substantially reduced by this damage. Repair was done by reinforcing local stability of the structure by installing additional stiffeners inside.

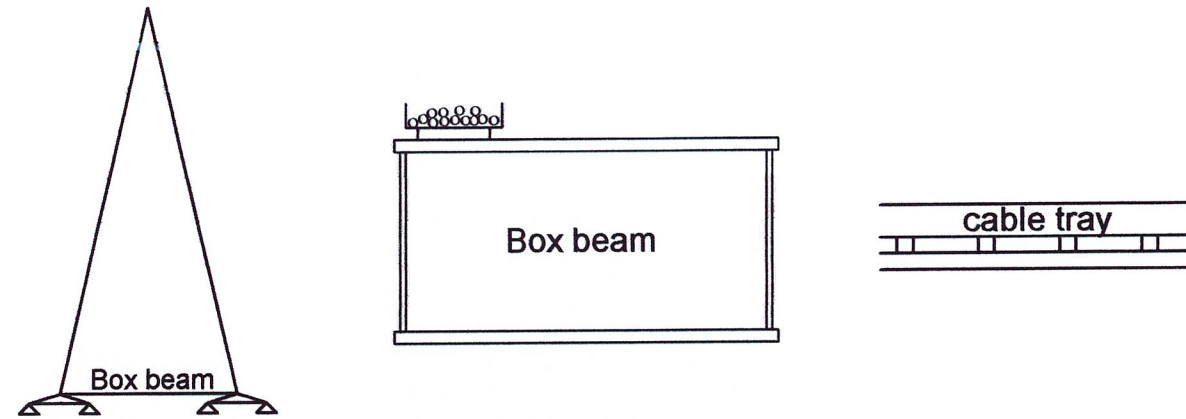
Figure 12: "Ghost" items – Case 3.

This example refers to the lower horizontal box girder of a triangular shear leg of a crane (Figure 12). The box girder had an approximate width of 800 mm and a height of 600 mm and was of the fully seal-welded type, e.g. there was no access into the interior. A cable tray was running on top of this box girder, sitting on "buckles" welded to the top flange. These buckles were so low (30 mm) that it was impossible to look properly under the tray.

The first indication was that the zone under the cable tray was heavily corroded. After removal of the cable tray and cleaning of the rust underneath, five small holes were discovered with a diameter of approx. 6 to 8 mm in the zone under the tray, in a rather concentrated area. A wire test established that they were going through the thickness of the flange. These holes must have been drilled before installation of the tray, which, evidently, was never removed before.

Result of these holes was water penetration inside the box beam, a fact that remained unknown for 30 years. The beam had no protective coating on the inside and, in consequence, heavy corrosion has formed. The box beam was opened on the side and about 50 buckets of rust mud were removed. The thickness reduction of the plates was about 50% in the bottom flange, 30% in the webs and 20% in the top flange. The only

favorable issue was that the holes were very small, their diameter further reduced by rust. As a result, water and oxygen penetration remained restricted.

In order to fix the problem of the box beam under permanent tension, it was recommended to use reinforcing strips in the areas affected.
